Manhole Inspection Summary

Manhole # S65G__019MH

Insp Date: **3/14/08 10:37 AM**

Location Address: **332 El Rino St.**

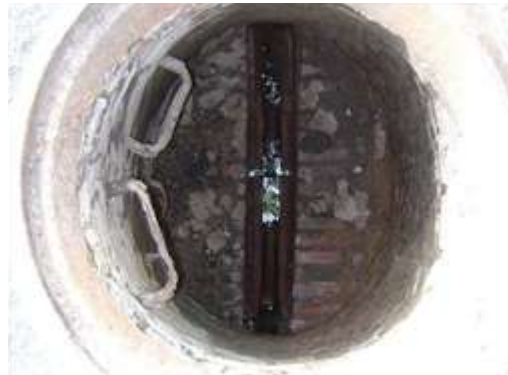
Top View

Condition: ☐ Sound ☐ Cracked ☐ Root Intrusion ☒ **Loose Brick** ☒ **Deteriorated**

Condition: ☐ Sound ☐ Cracked ☐ Root Intrusion ☐ Loose Brick ☒ **Deteriorated**
